DELAWARE RIVER BASIN

POCONO LAKE DAM
MONROE COUNTY, PENNSYLVANIA

6 PHASE I INSPECTION REPORT
NATIONAL DAM INSPECTION PROGRAM.

11 JULY 1979

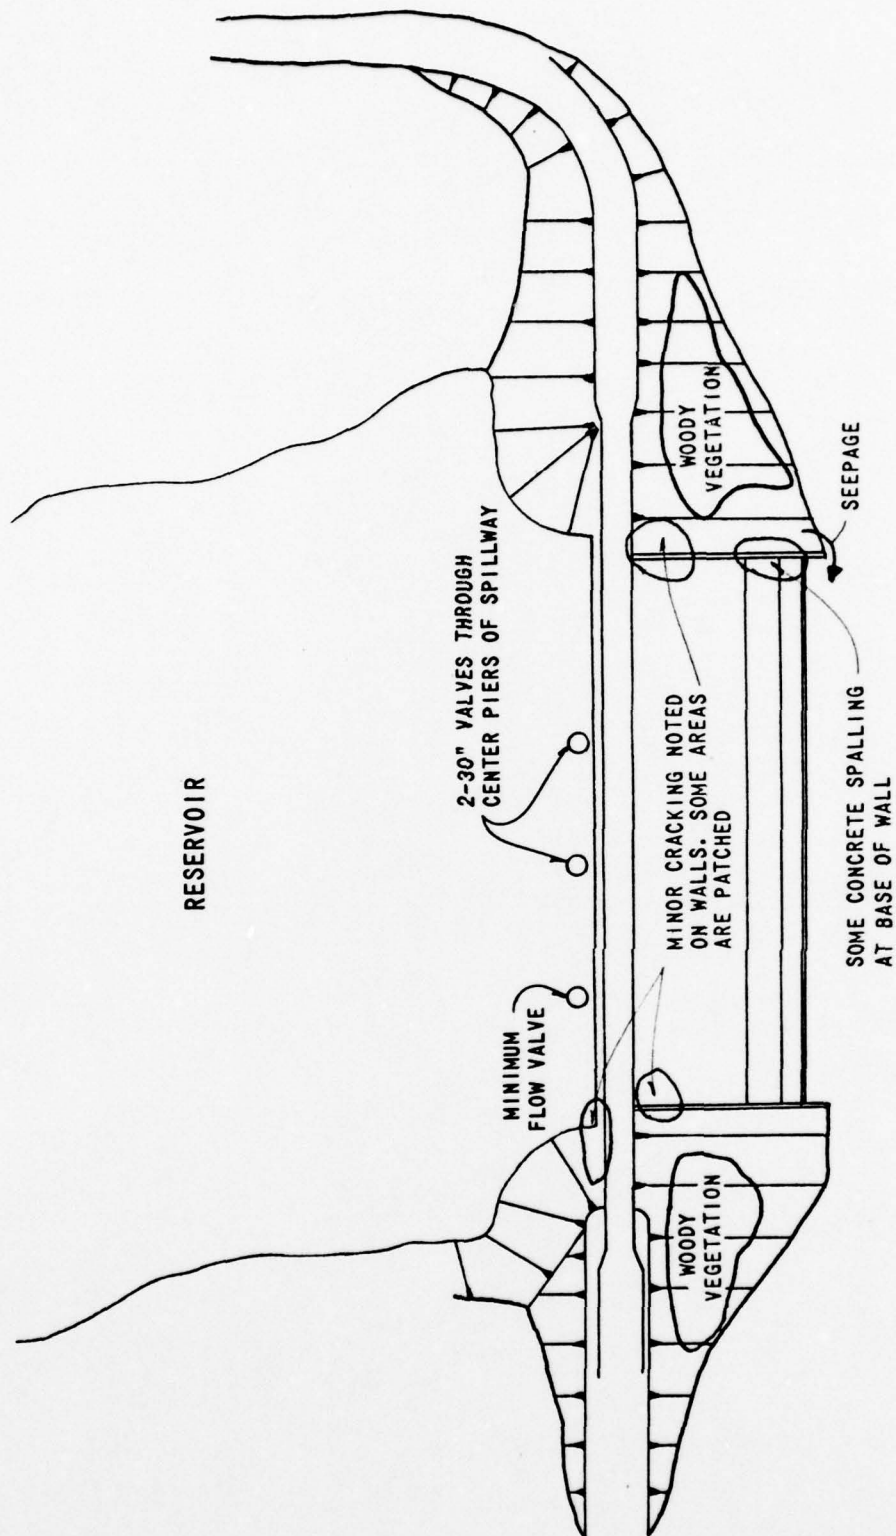
FIELD OBSERVATION PLAN
POCONO DAM

RETAINING WALLS	Some spalling noted at base of retaining walls as shown on Sheet 5a and photographs. This spalling should be repaired.	
-----------------	--	--

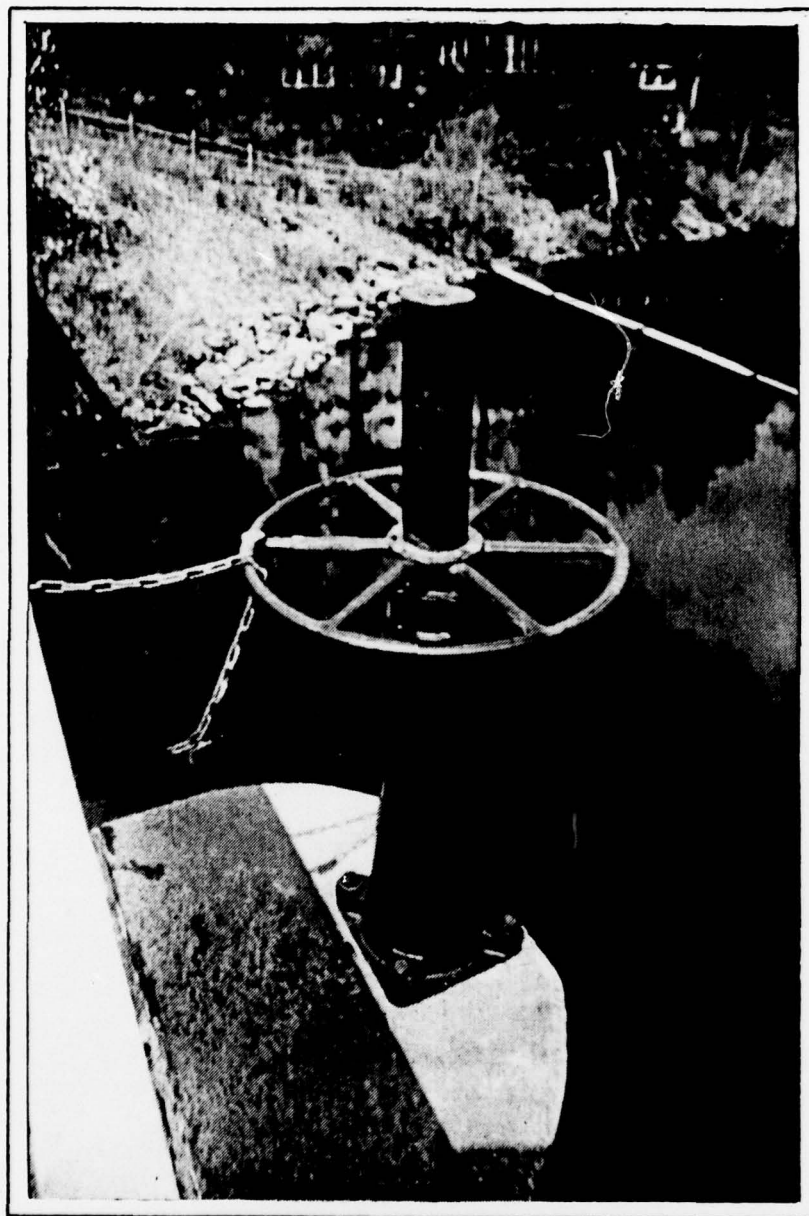
PHOTOGRAPH NO. 1

VALVE USED TO CONTROL
MINIMUM FLOW RELEASE.

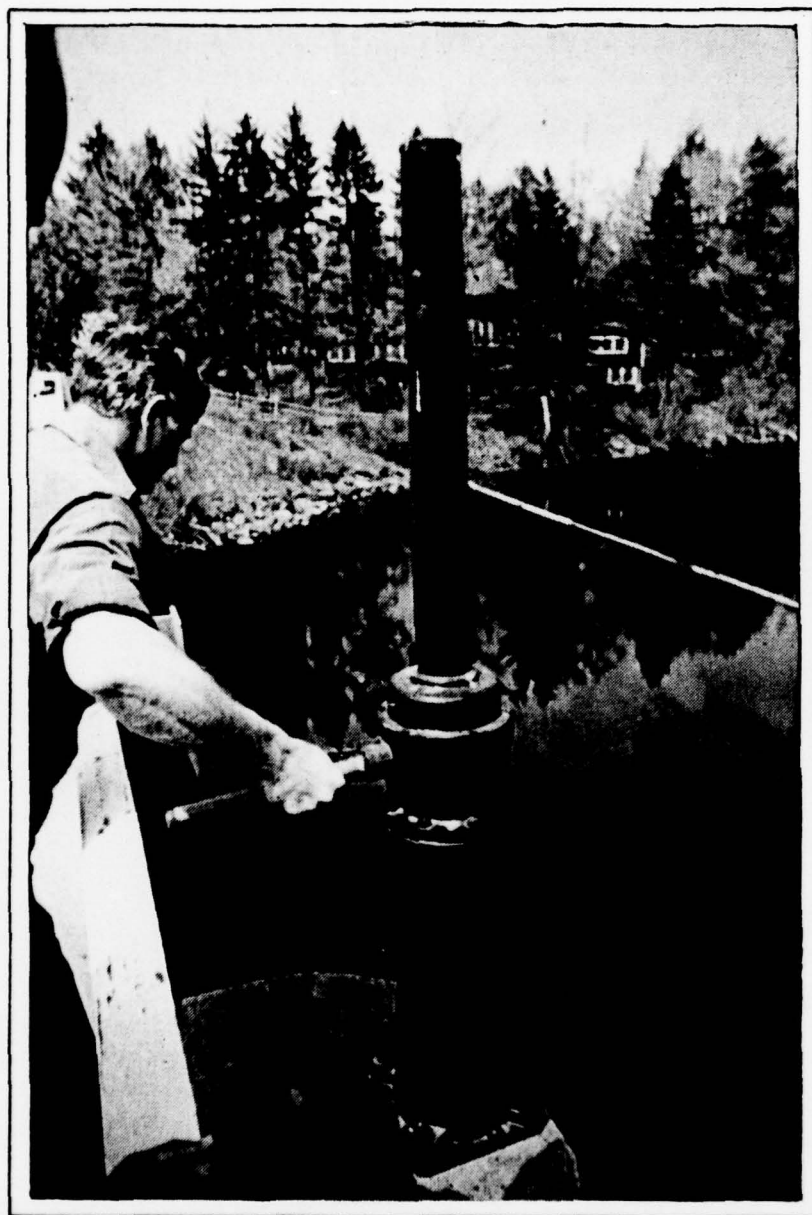
TYPICAL OUTLET CONTROL VALVE.

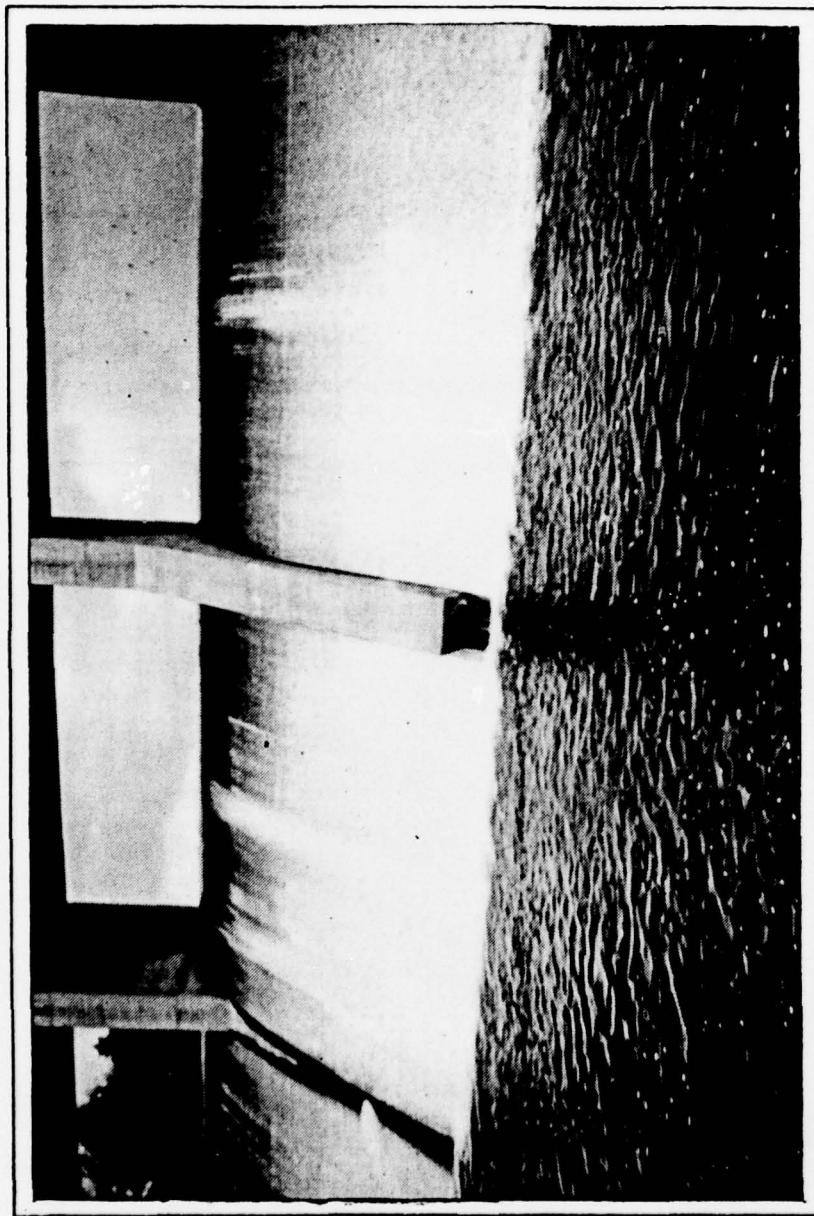
PHOTOGRAPH NO. 3

VIEW OF SPILLWAY. NOTE MINIMUM
FLOW DISCHARGE OUTLET ON THE LEFT
OF PHOTOGRAPH.

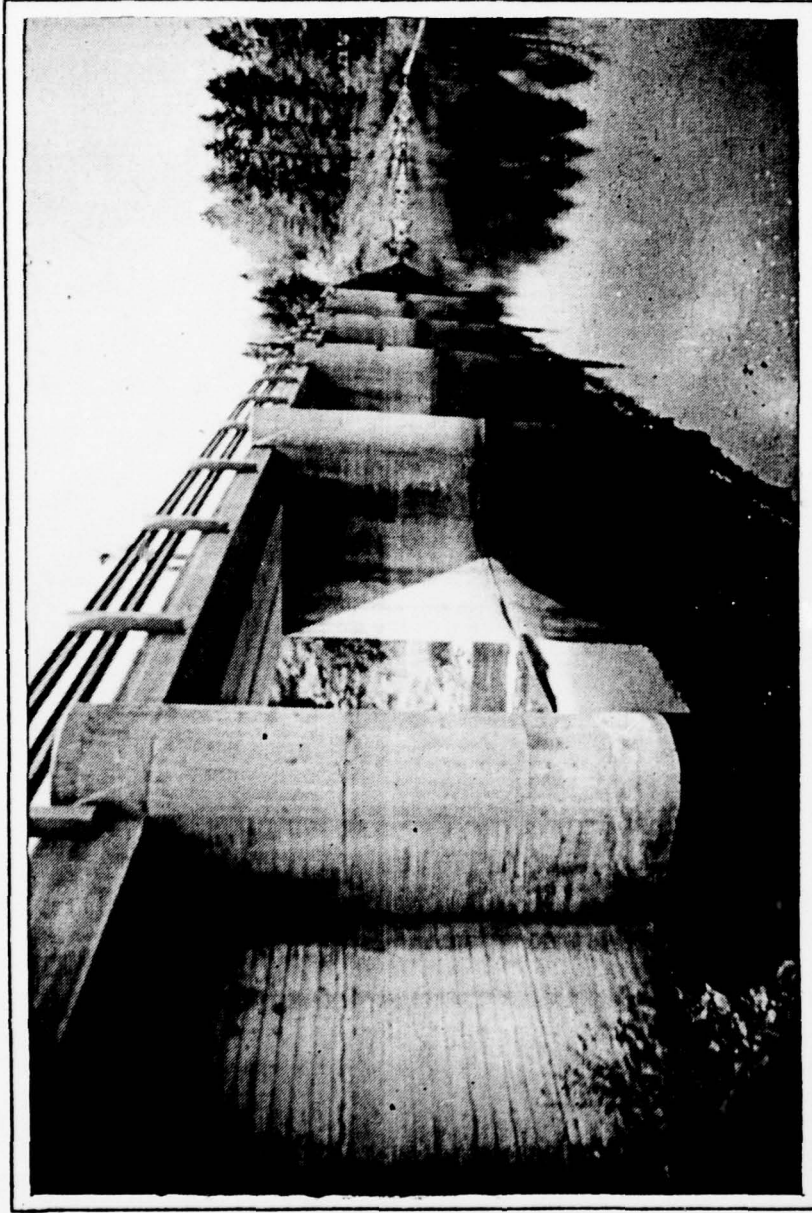
PHOTOGRAPH NO. 4

OVERVIEW OF UPSTREAM SIDE OF
SPILLWAY.

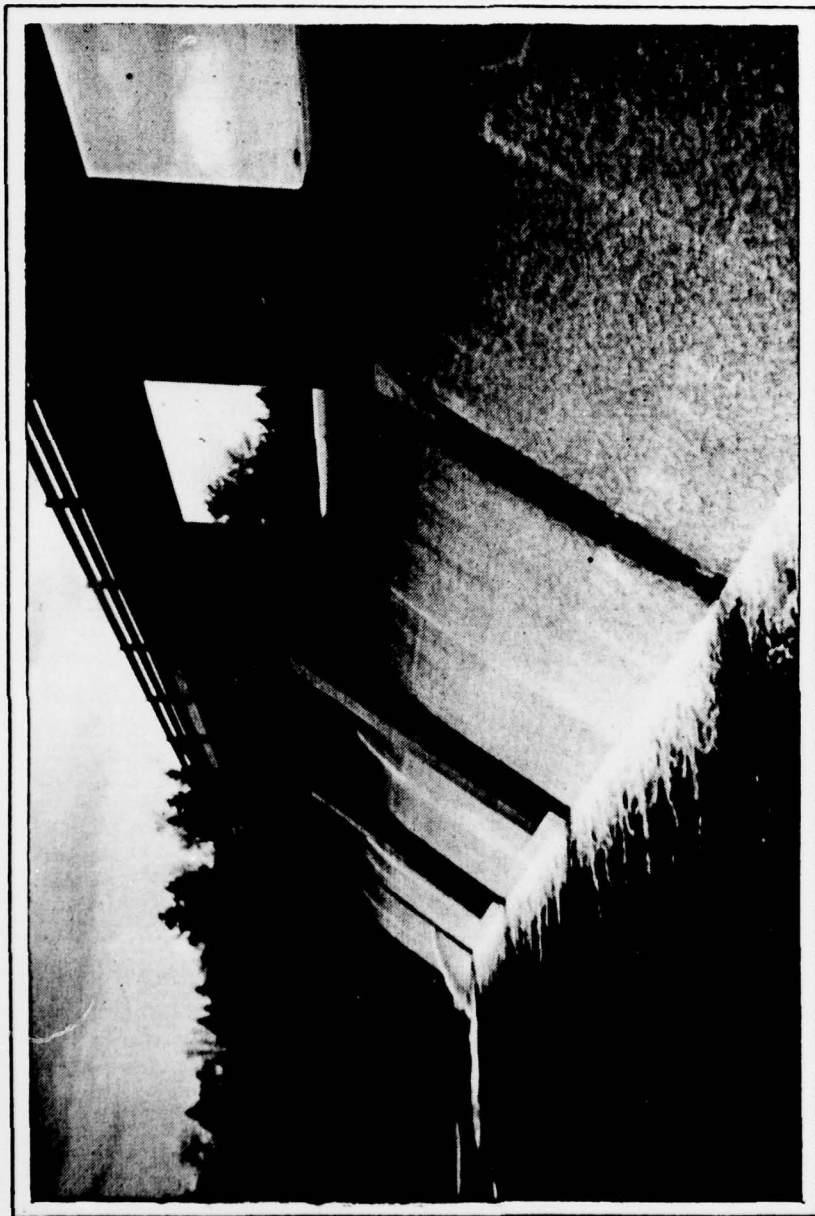
PHOTOGRAPH NO. 5

OVERVIEW OF DOWNSTREAM SIDE OF
SPILLWAY.

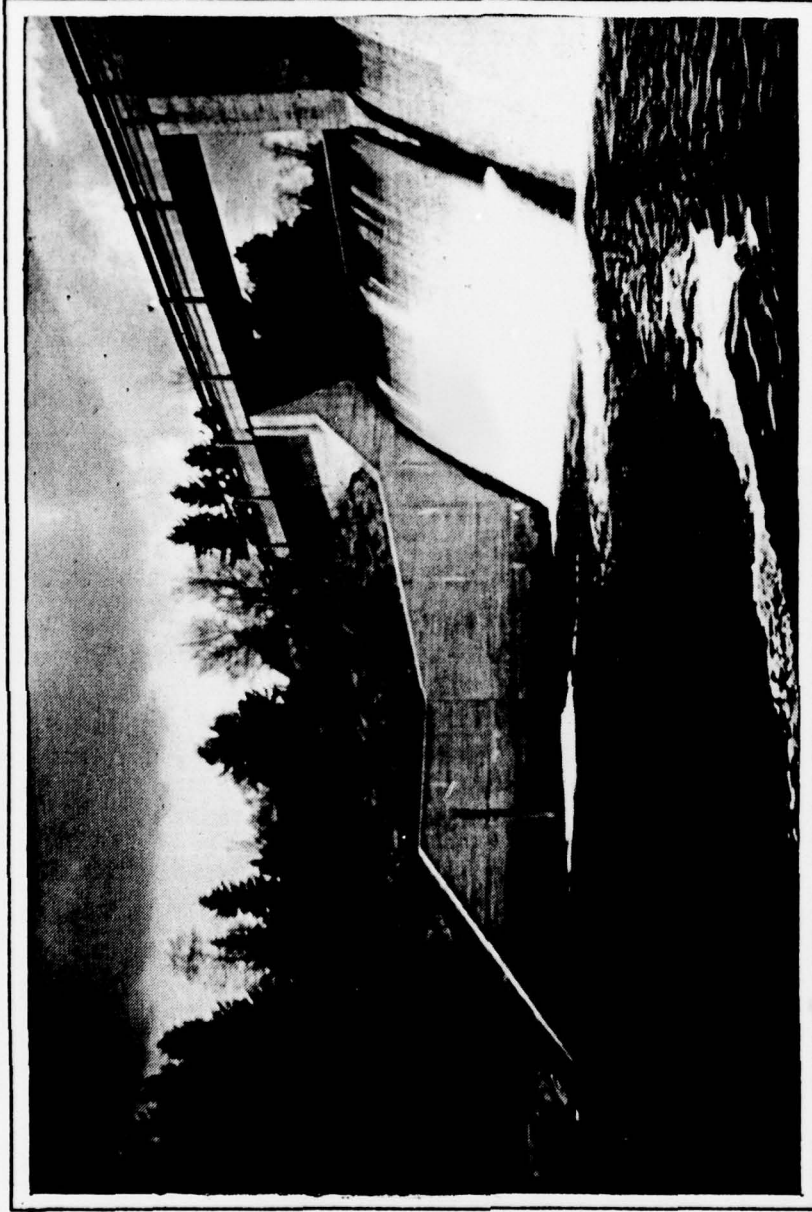
PHOTOGRAPH NO. 6

STAFF GAGE AND RECORDER	Gage on downstream, right spillway wall is not legible.	
-------------------------	---	--

OVERVIEW OF RIGHT WALL OF SPILLWAY.
NOTE STAFF GAGE ON WALL.

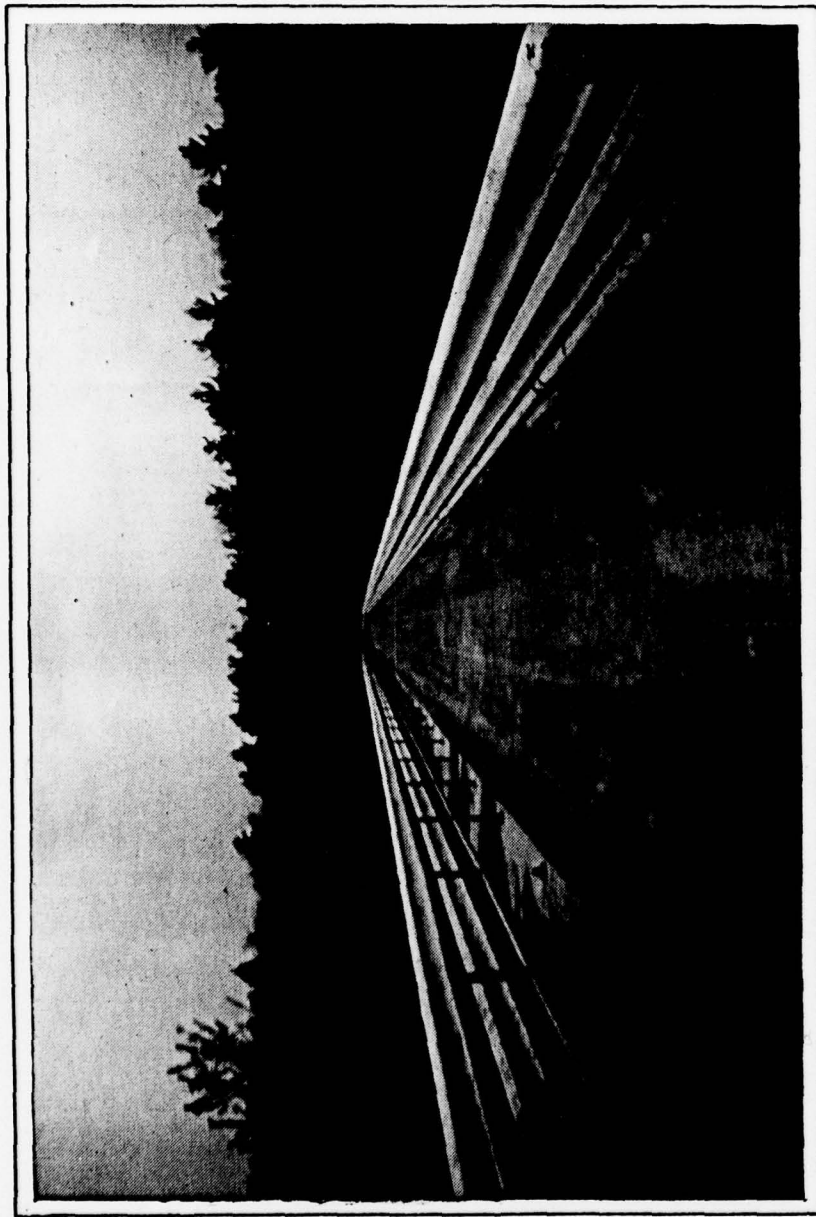
PHOTOGRAPH NO. 8

LOOKING AT ROADWAY ACROSS SPILLWAY
FROM THE RIGHT ABUTMENT.

4. The joint sealer beneath the bridge decking should be replaced as soon as practical. If the joint is allowed to remain open and fill with soil or water, spalling at the joints could occur.

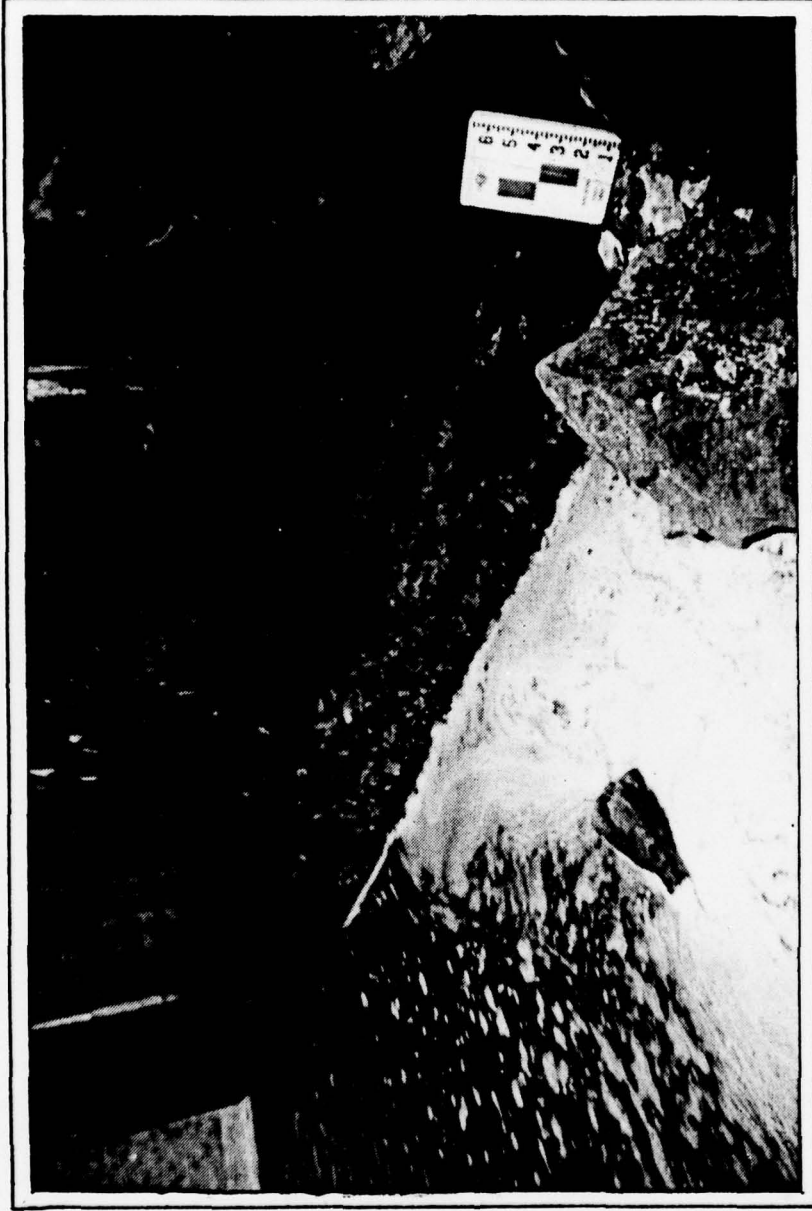
PHOTOGRAPH NO. 10

SPALLING AND GENERAL CONCRETE
DETERIORATION OF LEFT SPILLWAY
WALL AT STILLING POOL ELEVATION.

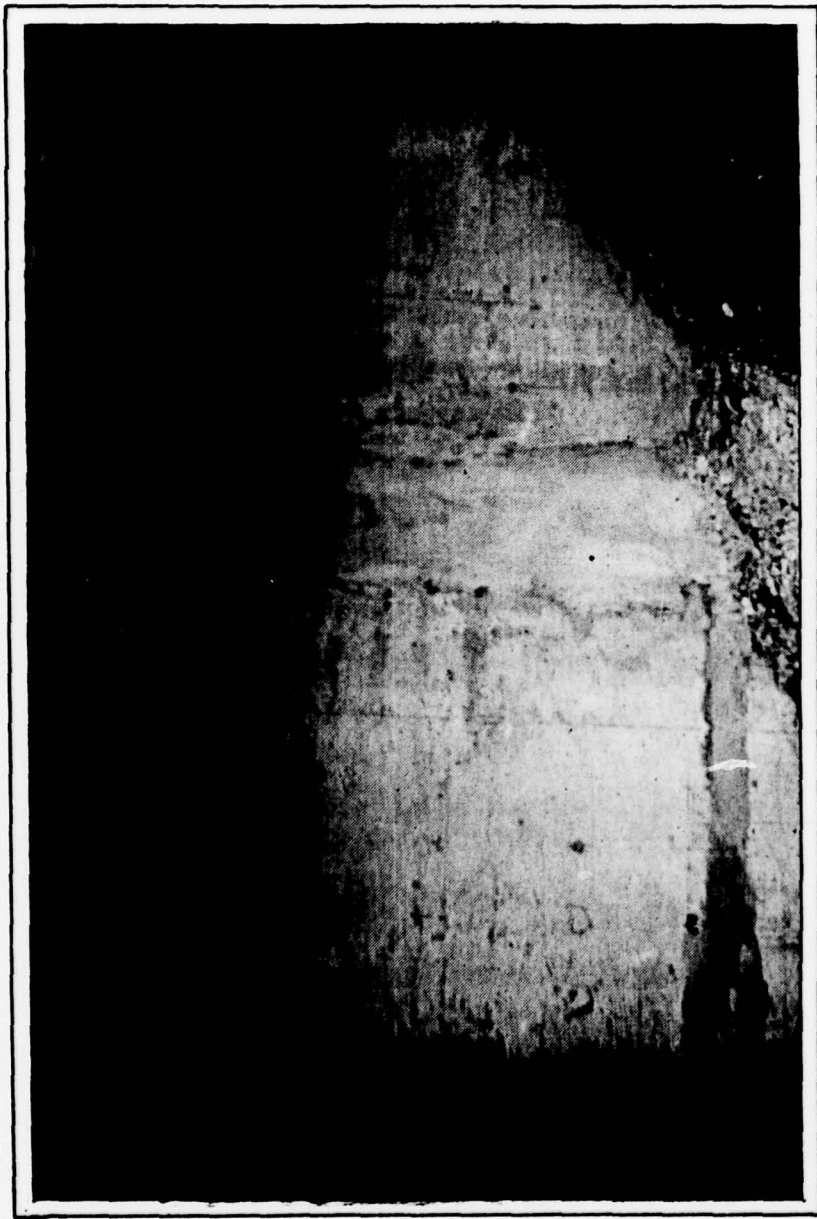
PHOTOGRAPH NO. 12

TYPICAL CONCRETE REPAIR WORK
PERFORMED ON DAM.

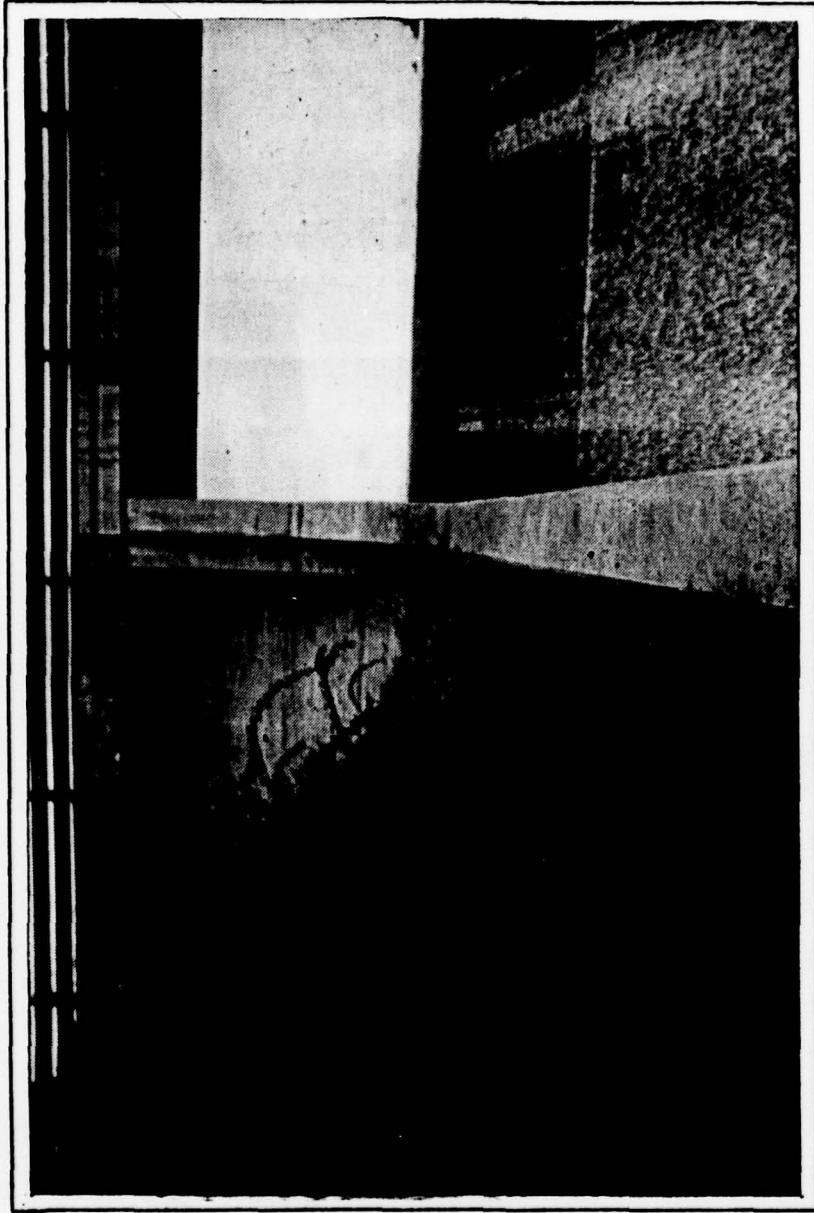
PHOTOGRAPH NO. 13

OVERVIEW OF RIGHT SPILLWAY ABUTMENT
LOOKING UPSTREAM.

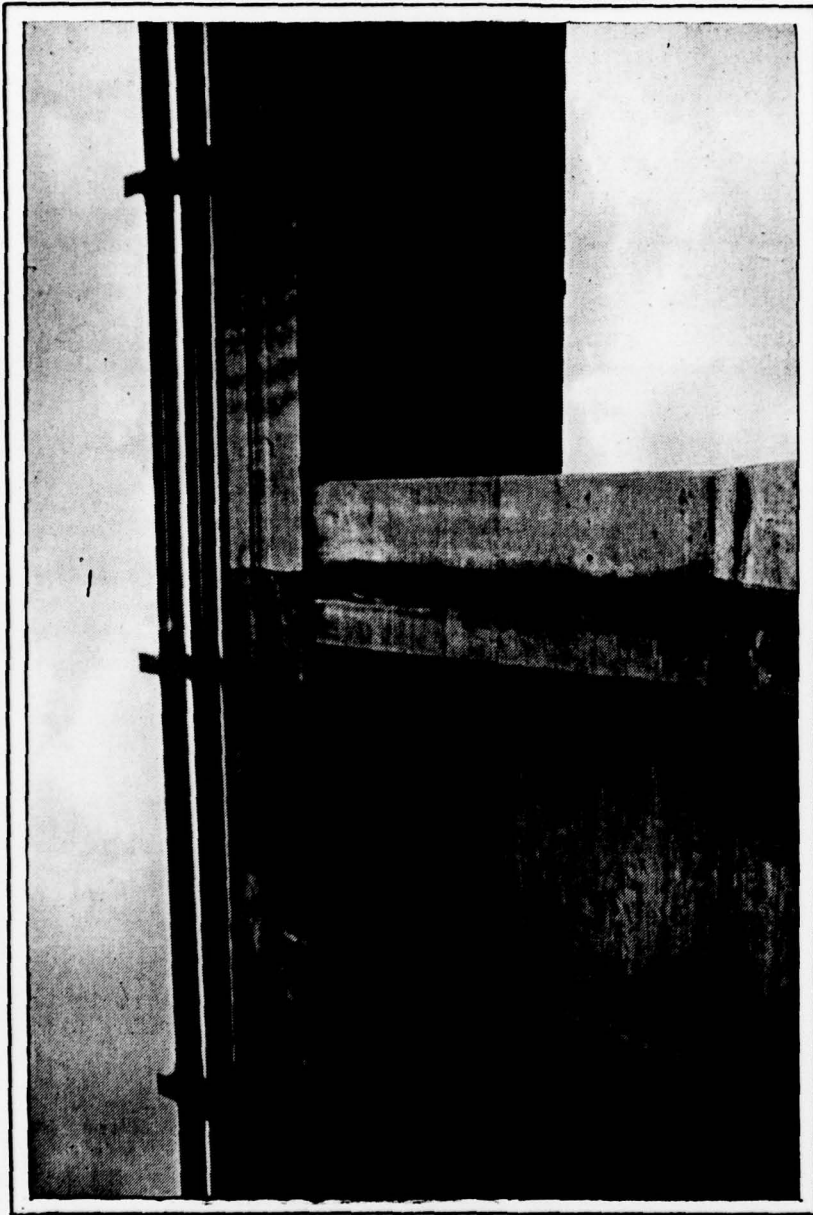
PHOTOGRAPH NO. 14

NOTE DETERIORATION OF BRIDGE
ABUTMENT. REFER TO PHOTOGRAPH
NO. 13 FOR LOCATION.
